# [ SEFA RESULTS ]

## SEFA 8 CERTIFICATE OF PERFORMANCE INDEPENDENT TEST LAB

## LABORATORY FURNITURE - SEFA 8

## DESCRIPTION OF TEST CABINET

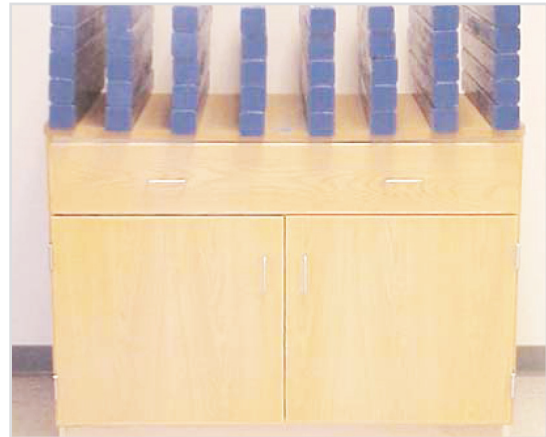
## CABINET LOAD TEST

The cabinet top was loaded using 2,000 pounds of solid steel bars stacked five high, in eight equally spaced rows. After 10 minutes, the bars were removed from the cabinet.

There are no signs of permanent damage.

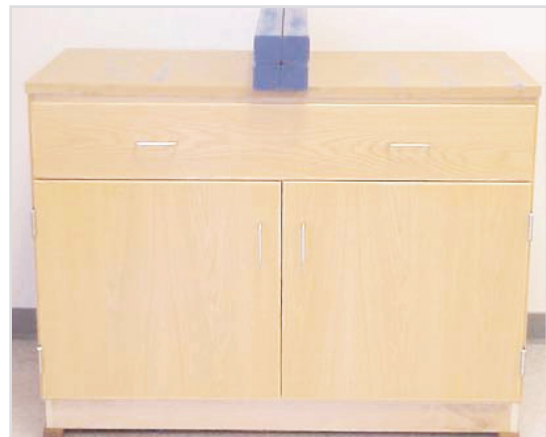
## CABINET CONCENTRATED LOAD TEST

Four, 50 pound solid steel bars were placed on top of the cabinet, along the cabinet centerline. With the weight in place, the drawers and doors were operated and inspected.

Doors and drawers operated normally. There is no permanent distortion to the front rail, cabinet joinery, doors, or drawers.

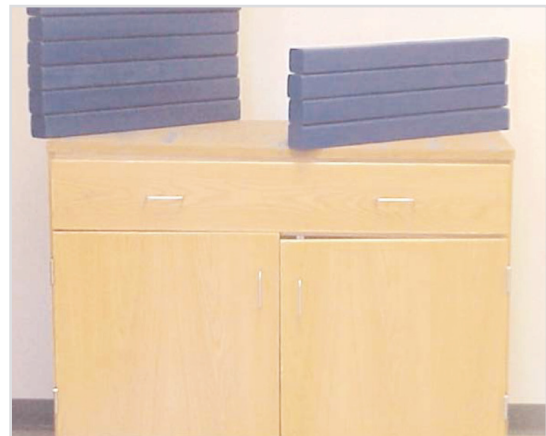
## CABINET TORSION

The cabinet was supported on three, 3-1/4" x 3-1/2" x 4"H hardwood blocks, located under the two rear corners and one front corner. The cabinet was secured, diagonally from the unsupported corner with seven, 50 pound, solid steel bars to prevent overturning. Four, 50 pound, solid steel bars were placed on the unsupported corner of the cabinet and left in position for 15 minutes. The weights were then removed and the cabinet was placed on the floor in its normal, upright, position. The cabinet joinery was inspected and the cabinet was leveled and measured, diagonally, between the corners of the face and the back of the cabinet.

When returned to normal position, the operation of the cabinet was normal and there was no evidence of permanent damage. The difference between the diagonal measurements does not exceed 1/8" front or back.

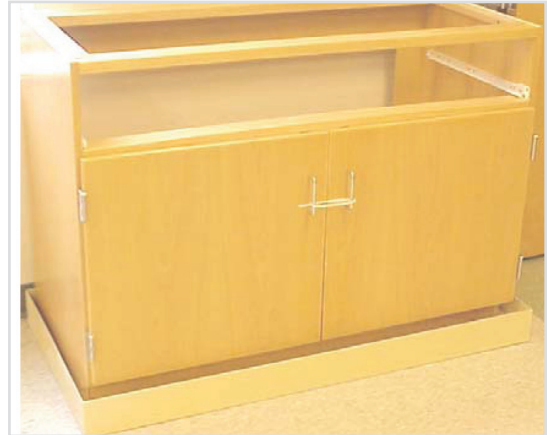
## CABINET SUBMERSION TEST

The thickness of the material along the perimeter of the bottom of the cabinet was measured on 6" increments. The thickness was recorded and the arithmetic mean was calculated. The cabinet was then placed in a pan of water so that the bottom 2" of the cabinet was submerged. The cabinet remained in the water for 4 hours and then it was removed and immediately re-measured at the same locations that were measured initially. The thickness at each location was recorded and the arithmetic mean was calculated. After the cabinet had dried, it was inspected for damage.

The cabinet shows no signs of permanent deformation or deterioration and the average increase in thickness is less than four percent (3.5%).

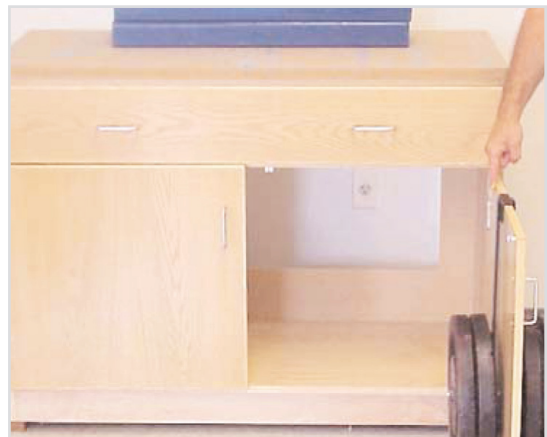
## DOOR HINGE TEST

The shelf was removed and weight was placed on top of the cabinet to prevent it from overturning. A cabinet door was opened 90° and a sling with four 50 pound weights was hung over the top of the door, at a point out from the hinge centerline. The door was then slowly moved through the full cycle of the hinge (up to a 160° arc). The weight was then removed, the door was swung through its full intended range of motion, and closed.

There was no significant permanent distortion and the door operated normally after the weight was removed.

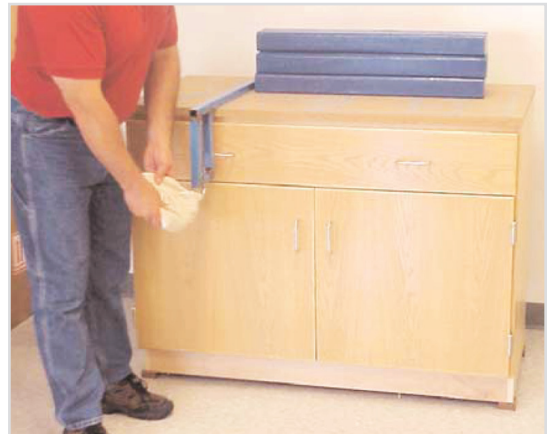
## DOOR IMPACT TEST

Eight, 50 pound solid steel bars were placed on top of the cabinet to prevent overturning. A 20 pound sand bag was then suspended from a pendulum support and dropped providing an impact of 240 inch-pound at the center of a closed door.

Door and catch operated normally and show no signs of permanent damage.

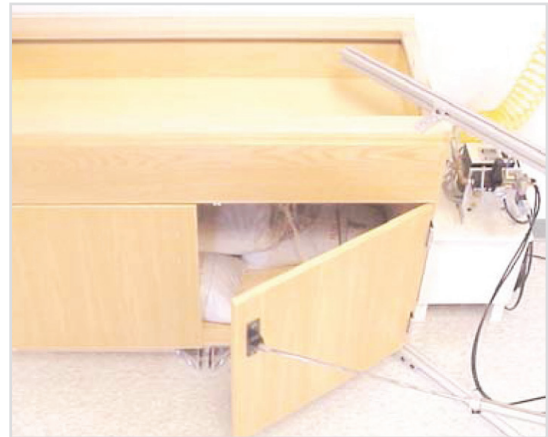
## DOOR CYCLE TEST

A cycling mechanism, that swings a door through an arc of 90°, was operated for 100,000 cycles.

The door operated for the full 100,000 cycles without deterioration that significantly affected the function of the door. After completion of the test, the door operates freely and without binding.

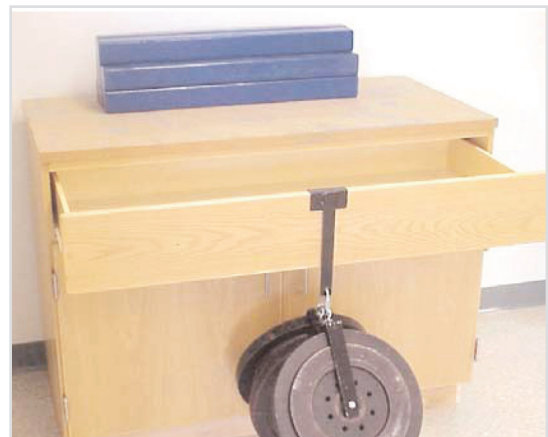
## DRAWER STATIC LOAD TEST

Eight, 50 pound solid steel bars were placed on top of the cabinet to prevent overturning. A drawer was opened to 13" of travel and 150 pounds was hung from the drawer head, at the centerline of the drawer, for 5 minutes. The weight was then removed and the drawer was operated through the full cycle.

There was no interference with the normal operation of the drawer.

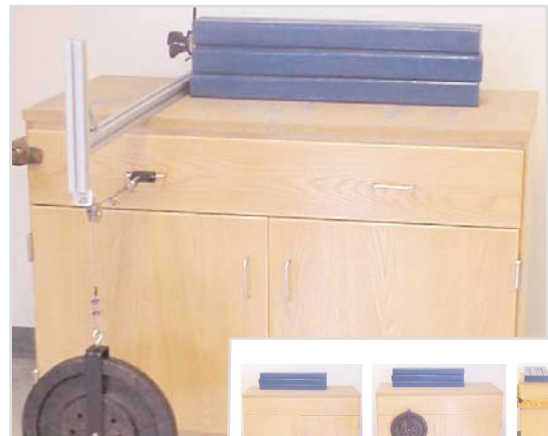
## DRAWER & DOOR PULL TEST

The pulls were installed in accordance with Diversified Woodcrafts practice using specified attaching hardware and method. A drawer and a door were blocked closed and a cable, pulley, and weight assembly was used to apply a force of 50 pounds perpendicular to each pull. Similar set-up was then used to hang a 50 pound weight from each pull.

Pulls resisted the force and supported the weight and there is no evidence of permanent distortion..

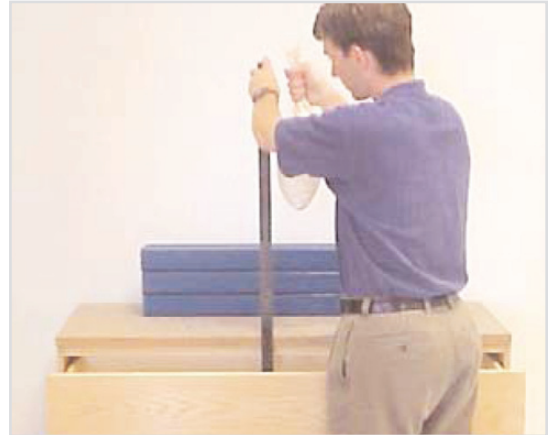
## DRAWER IMPACT TEST

A drawer was opened to 13" of travel and then a 10 pound sand bag was dropped, from a height of 24", into the bottom of the drawer, at the centerline of the width of the drawer and 6" back from the inside face of the drawer.

The drawer was operated through a full cycle and it operated normally. There was no visible deformation of the drawer.

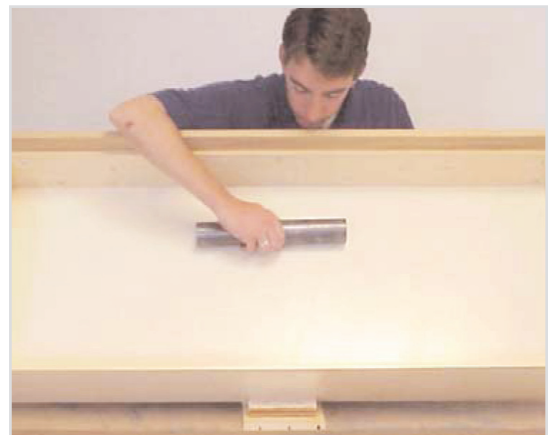
## DRAWER INTERNAL ROLLING IMPACT

The drawer was positioned on a table at a 45° angle and a 2" diameter by 12" long steel rod, that weighs approximately 10 pounds, was positioned 13" from the target impact area such that the rod rolled freely to impact the back of the drawer. The back was subjected to three impacts and then the drawer was reversed and the front was subject to three additional impacts.

There are no visible signs of permanent damage. All joinery is intact and the drawer operated normally when returned to the unit.

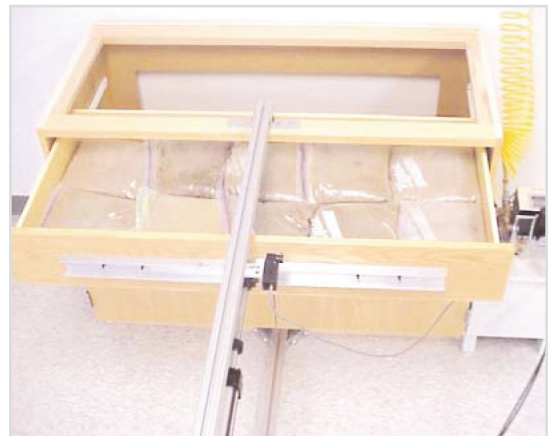
## DRAWER CYCLE TEST

A static load of 100 pounds (using ten 10 pound sand bags) was uniformly distributed in a drawer and the force required to activate the drawer was measured. The drawer was then opened from a closed position to a position within 1/4" of full extension and then closed. The procedure was repeated 50,000 times at a rate that did not exceed 10 cycles per minute.

After the 50,000 cycles were completed, the drawer operated freely with no evidence of dragging, rubbing, or binding. The force required to open and close the loaded drawer increased by 7.1% which is less than the allowable maximum (20%). The force required to open and close the loaded drawer was less than 8 pounds.

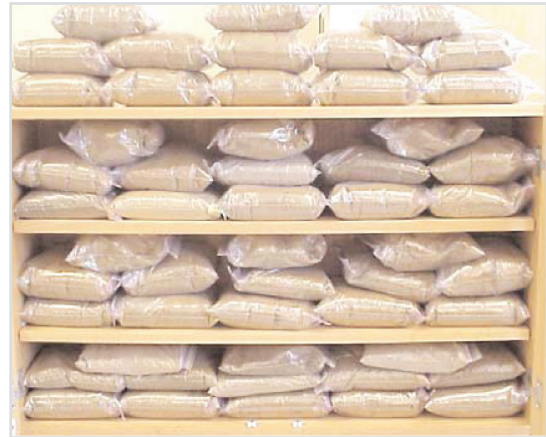
## SHELVING

The shelf was mounted in the manner in which it was designed and a dial indicator was positioned under the center of the shelf and adjusted to zero. Thirteen 10 pound sand bags were uniformly distributed on the shelf to obtain a loading of 40 pounds per square foot of shelf area and the deflection was recorded. The weight was then removed from the shelf.

The deflection of the shelf under load - 0.245" which is less than the allowable maximum of 0.25." There was no significant permanent distortion of the shelf.

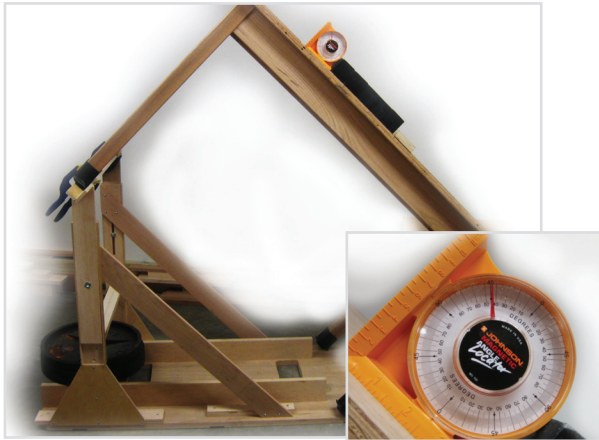
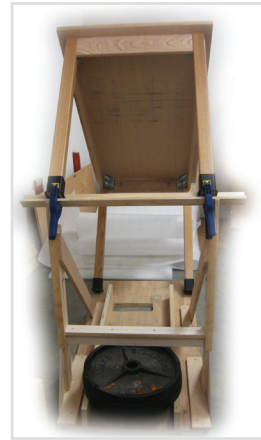
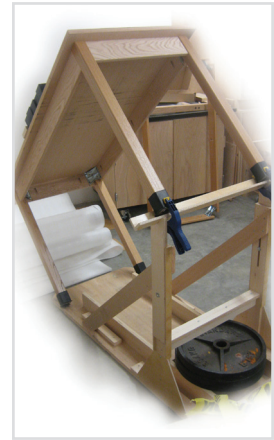
## WALL CABINET LOADING TEST

130 pounds of sand bags, 40 pounds per square foot, were used to load the cabinet bottom, the cabinet top and shelves. With the weight in place the doors were operated through their full travel to verify normal operation. The weight was then removed and the doors were again operated through their full travel to verify normal operation.

Doors opened and closed normally with and without the weight in place. There is no significant permanent deflection or damage to cabinet, cabinet back, cabinet top, cabinet bottom or shelf.

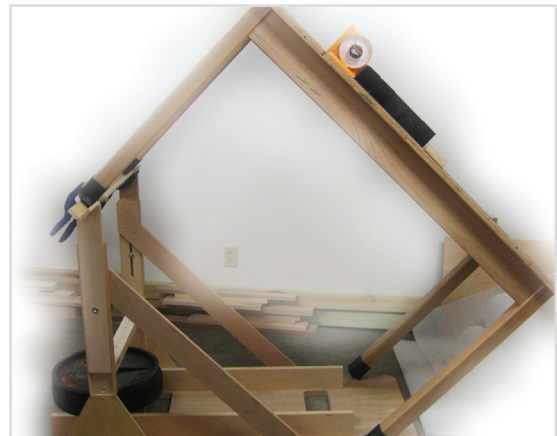
## TABLE TEST

The table shall have a common two-by-four wood rail clamped on the centerline of the top parallel to the ends of the table. The table shall then be positioned at 45°, with one pair of legs on the floor and the other raised and supported (see Figure 14). The table shall then have 250 pounds (113.398 Kg) of weight (five 50-pound (22.679 Kg) bars) placed on its top and held in place by the two-by-four wood rail. The unit shall remain in this position for seventy-two hours. The unit shall be lowered without shock to the leveled surface and the general operation of the drawers shall be evaluated.

When returned to normal position, the operation of the table was normal, and there was no permanent damage.
